**Pacific Gas and  
Electric Company**

PG&E Letter DCL-04-119

Docket No. 50-275, OL-DPR-80  
Diablo Canyon Unit 1  
Licensee Event Report 1-2004-002-00  
Technical Specification (TS) 3.0.3 Required Shutdown Due to TS 3.7.7,  
"Vital CCW System," Limiting Condition for Operation (LCO) Not Met

4. TITLE TS 3.0.3 Required Shutdown Due to TS 3.7.7, "Vital CCW System," Limiting Condition for Operation Not Met
--

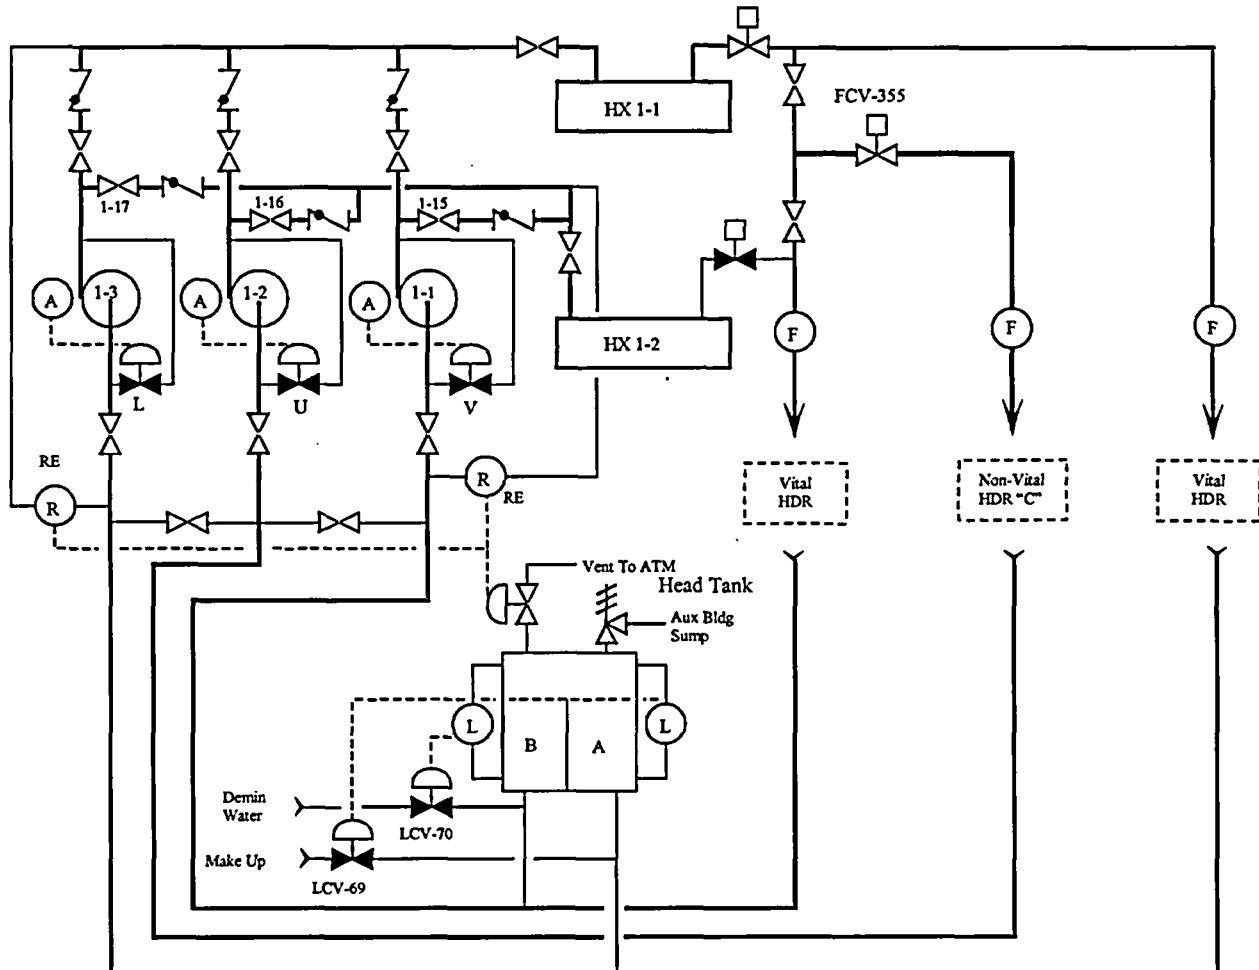
Figure 1

For a graphical representation of the CCW System, refer to Figure 1. Additional information on the design and operation of the system, along with a list of the components served, is presented in the Final Safety Analysis Report, Section 9.2.2, "Component Cooling Water System."
